Henry M. Jackson Hydroelectric Project
FERC No. 2157

**TERRESTRIAL RESOURCES
2022 ANNUAL REPORT**

April 2023

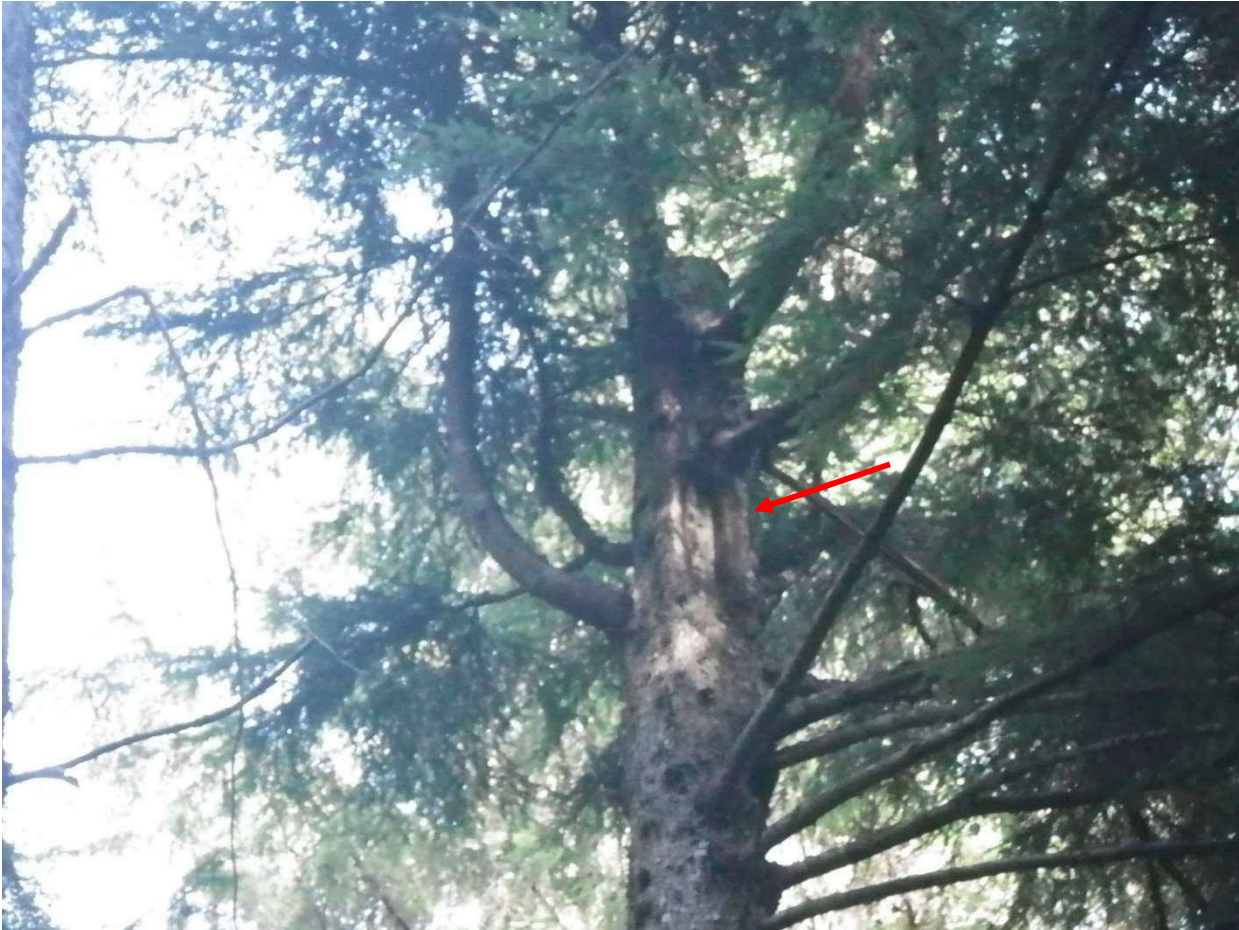
Figure 2-3 Created decaying live tree with “cat-faced scar” created near top (red arrow) and up- turned branches forming bushy top.

Preliminary results of the gap and WHS monitoring are encouraging. Many of the DLTs still survive and have upper branches turning upwards to form dense new tops (Figure 2-3). The age range of gaps sampled was from 2-10 years (from time of initial WHS creation). Within gaps, the average percent vegetative cover increased from primarily devoid of vegetation to a range of 40-68% (Figures 2-4 & 2-5). In terms of deer forage, nearly every gap had vaccinium, with typical heights ranging from 2-8 feet, with numerous gaps having evidence of deer browsing.

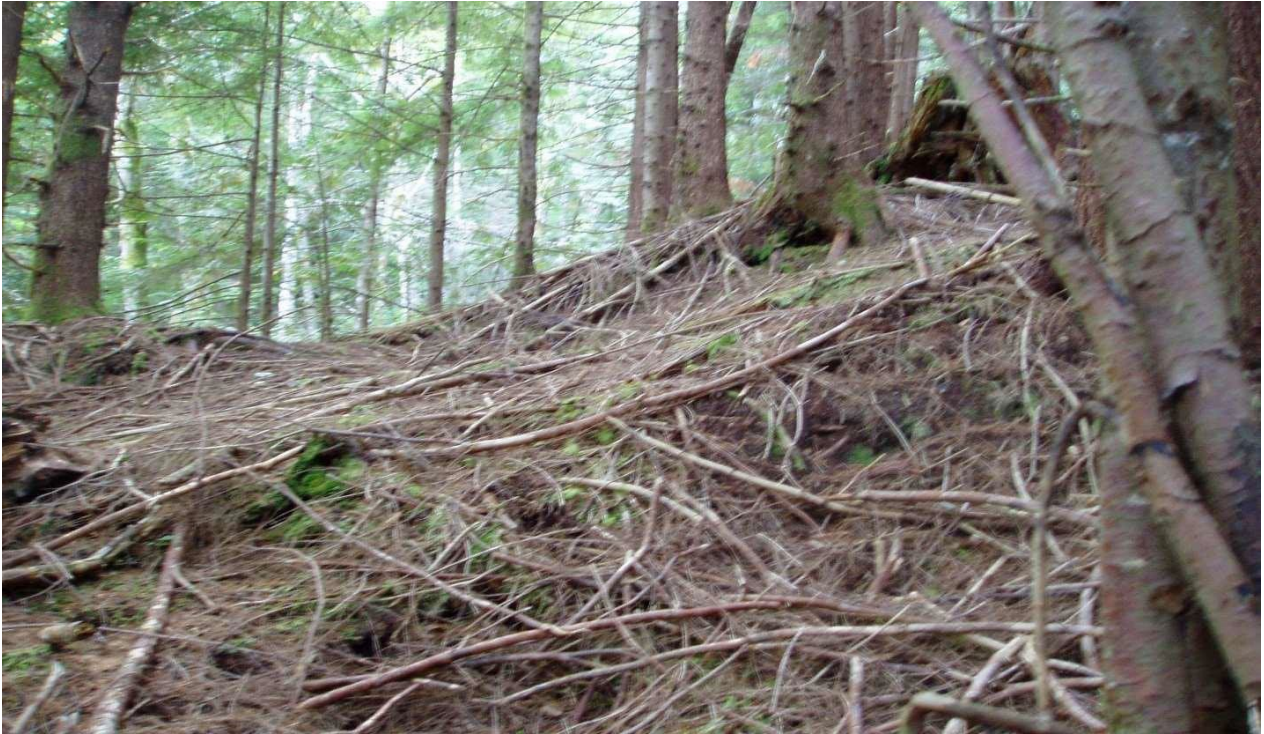
Figure 2-4 Typical understory in stands where no commercial thinning or gap creation has occurred.

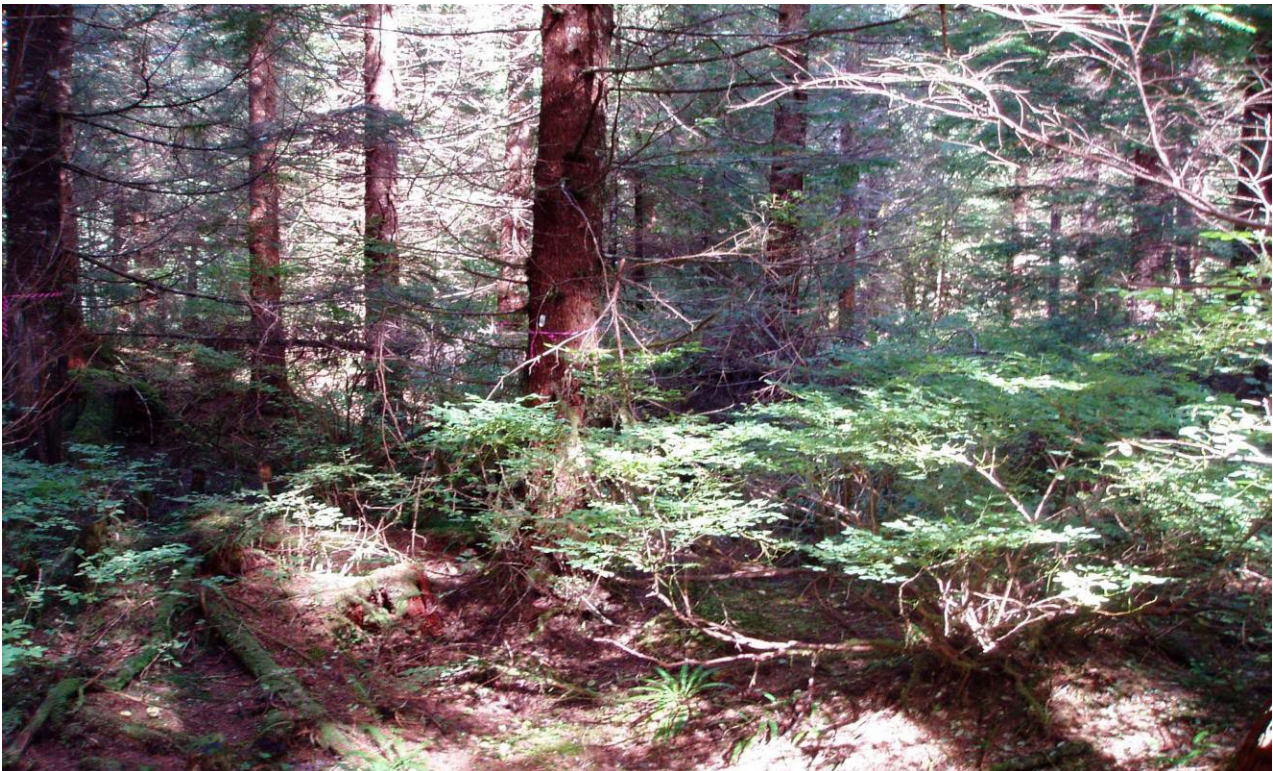
Figure 2-5 Post-gap creation, showing strong evidence of the impact of increased light input to gap.

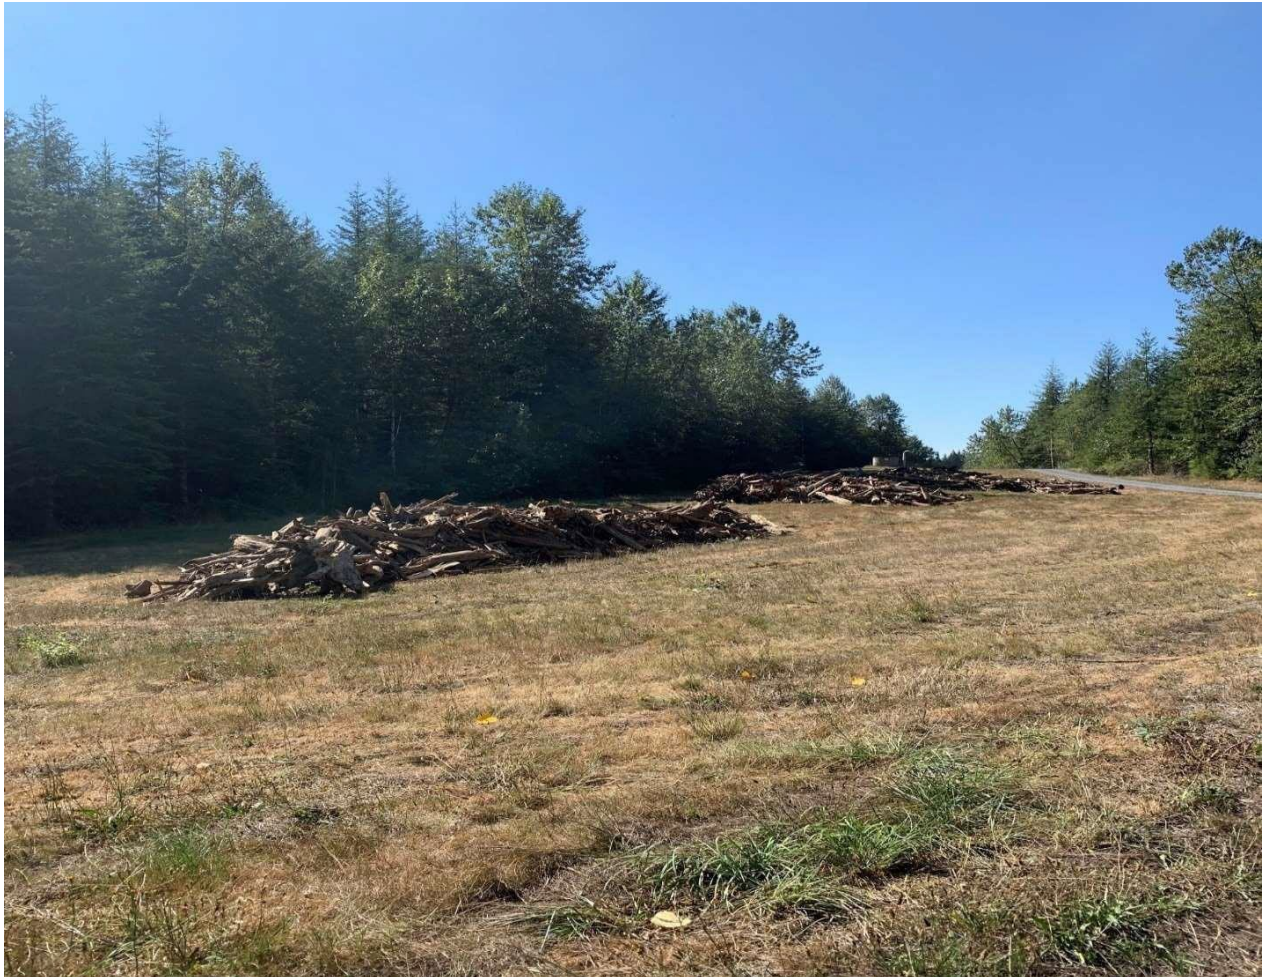
Figure 2-6 Woody debris piles deposited near P4 on lower pipeline ROW.

Several truckloads of wood from Culmback Dam that were not suitable for deposit into the riverine system were deposited on the lower pipeline ROW to provide hiding cover for small mammals and to break up the line of sight (Figure 2-6).
