CITY OF EVERETT FISH AND WILDLIFE HABITAT CONSERVATION AREAS (FWHCA) ASSESSMENT

HAT ISLAND SUBMARINE POWER CABLE REPLACEMENT PROJECT

OCTOBER 23, 2024

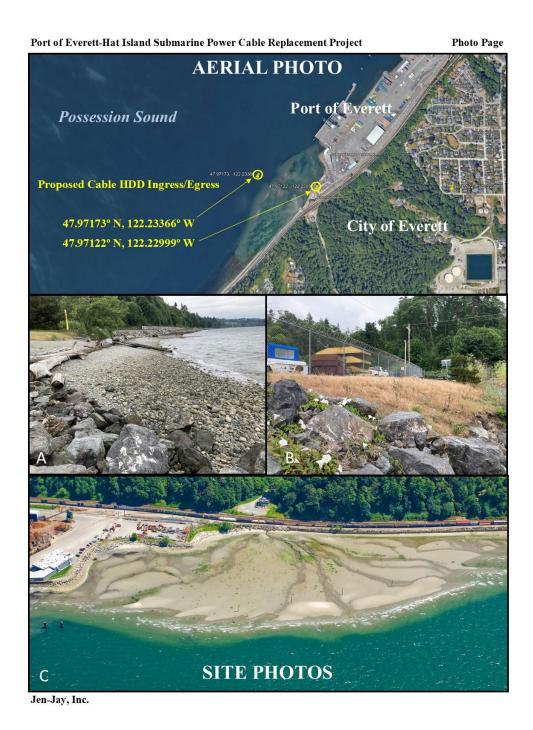
Figure 1. Aerial image showing Port of Everett property and proposed project site with location of HDD ingress and egress. Site photos include (A) Pigeon Creek Beach to the south of the project site; (B) HDD site immediately located inside the chain link fence of the Port of Everett project site; and (C) aerial view of the project site at low tide showing the beach contours.

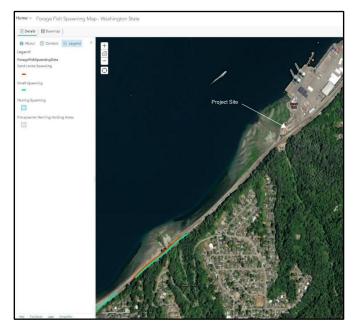
Figure 2: WDFW Forage Fish Spawning Map showing Pacific sand lance and surf smelt spawn along the beach southwest of the project site.

No shellfish areas of concern have been documented in the vicinity of the project and no forage fish are documented on the shoreline of the project site (Figure 2). The nearest Pacific sand lance and surf smelt spawning habitats are approximately a half mile southwest of the project site along Darrington Beach. The nearest herring spawning area is approximately 6.5 miles northwest of the project site in *Tulalip Bay*. Forage fish and shellfish areas of concern will be discussed further in the Critical Areas Section 3.1.2 Forage Fish and Shellfish Areas.

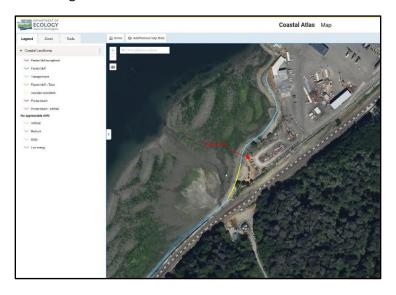
Figure 3: DOE Coastal Atlas showing the various coastal landforms at the project site.

The Coastal Atlas documents the shoreline slope stability as modified at the Port of Everett parcel. An approximate 225-foot stretch of coastline along Pigeon Creek Beach is designated as an accretion shoreform within the parcel's boundaries. The remainder of the northern coastline and an approximately 175 feet of coastline to the south of the accretion shoreform is designated as a transport zone. The remaining 375 feet of coastline at the most southwestern portion of the project's parcel is designated as feeder bluff (Figure 3). Littoral drift along this stretch of coast is from southwest to northeast.

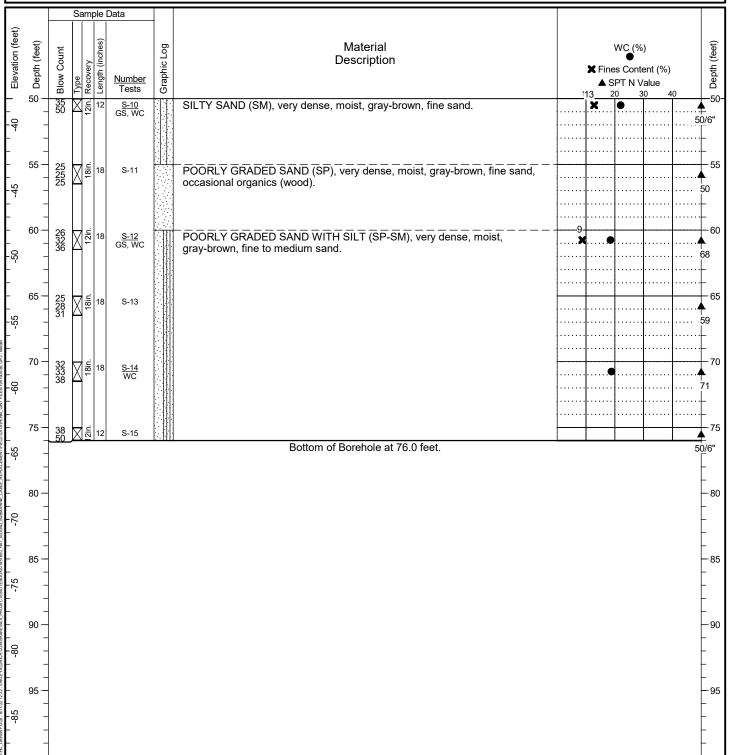
Date Started: 02/10/2020	Date Completed: <u>02/10/2020</u>	Drilling Contractor/Crew: Holocene Drilling, Inc. / Roddy					
Logged by: C. Kroskie	Checked by: Z. Yell	Drilling Method: Mud Rotary					
Location: Lat: 48.018713 Long: -122.3	321879 (WGS 84)	tig Model/Type: Diedrich D-120 / Truck-mounted drill rig					
Ground Surface Elevation: 12.00 feet	Hammer Type: Auto-hammer						
Comments: Hat Island		Hammer Weight (pounds): 140 Hammer Drop Height (inches): 30					
		Measured Hammer Efficiency (%): Not Available					
		Hole Diameter: Well Casing Diameter: NA					
		Total Depth: 76 feet Depth to Groundwater: Not Identified

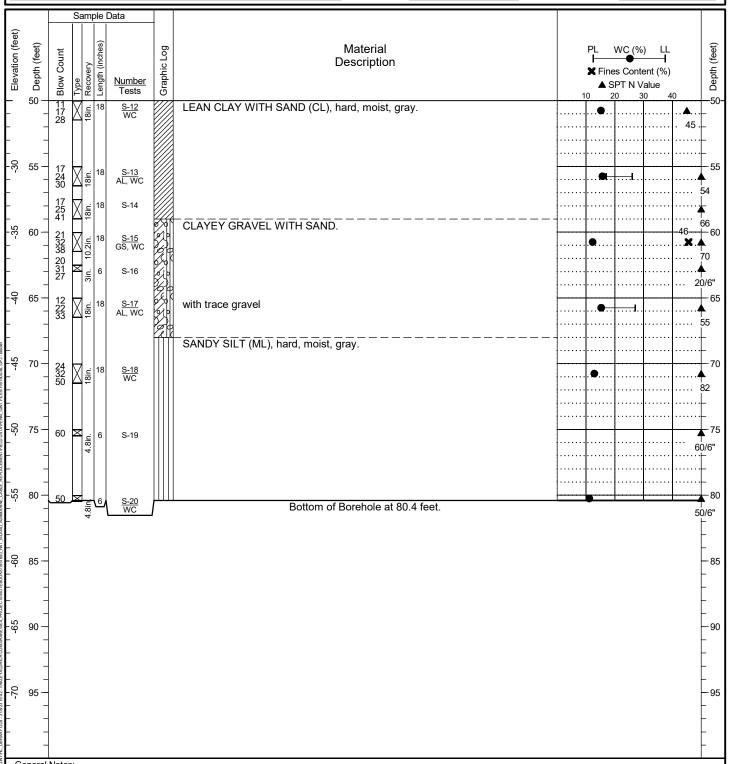
Drilling Contractor/Crew: Holocene Drilling, Inc.					
Drilling Method: Mud Rotary					
Rig Model/Type: Diedrich D-70 Turbo / Track-mounted drill rig					
Hammer Type: Auto-hammer					
Hammer Weight (pounds): 140 Hammer Drop Height (inches): 30					
Measured Hammer Efficiency (%): Not Available					
Hole Diameter: Well Casing Diameter: NA					
Total Depth: 80.4 feet Depth to Groundwater: Not Identified

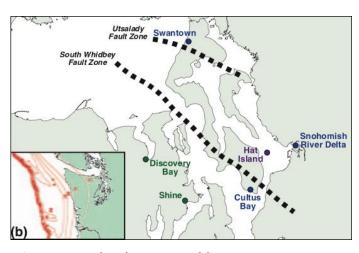
Figure 4. Faults closest to cable.

South Whidbey Island Fault Zone: SWIF is a broad, north-side-up fault zone (6–11 kilometers; 4–7 miles wide) dipping steeply to the northeast (Johnson 1996). The magnitude 7.4 earthquake modeled for the southern Whidbey Island fault zone is a shallow or crustal earthquake (Fig. 5). The

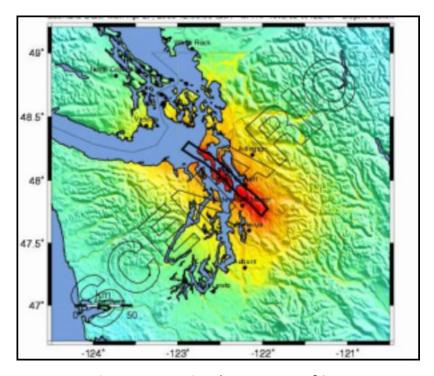
Figure 5. Intensity along rupture of SWIF.

Shallow quakes tend to be much more damaging than deep quakes of comparable magnitude (such as the M6.8 Nisqually earthquake in 2001). Excavations across several scarps near Woodinville revealed evidence of at least four earthquakes since deglaciation about 16,000 years ago, the most recent being less than 2,700 years ago.

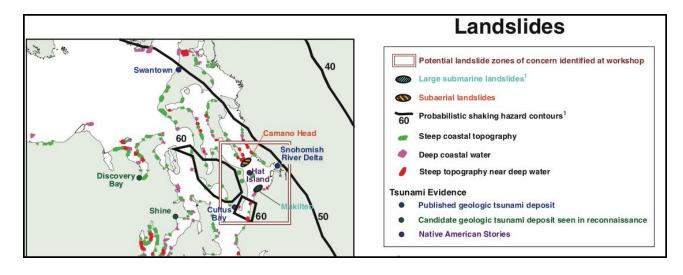
Figure 7. Examples of landslides in Puget Sound (Walsh 2002).

Landslides: Water saturation of loose sediments is the primary trigger of landslides in Puget Sound (Fig. 7). Other triggers can result from seismic events (earthquakes), deposition of eroded bluff sediments on the steep slopes, and rapid deposition of sediment offshore from flooding rivers. Slope failures in the loose, fine to medium-grained glaciomarine sediment occur as either retrogressive flow slides (RFS) or spontaneous liquefaction (SL). The RFS start in some area of the slope and develop retrogressively up slope. SL slides initiate at a point and spread in all direction, up and down slope at a very high rate.

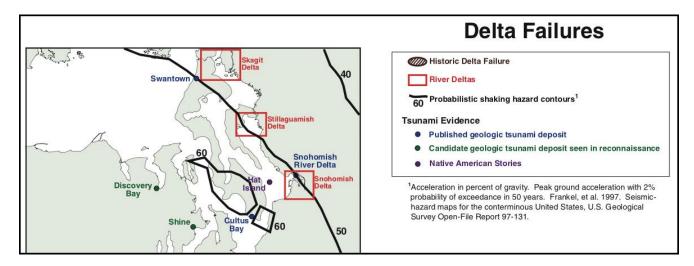
Figure 8. Areas of potential delta failures that may generate tsunamis or turbidity currents (Walsh 2002).

A landslide in 1820 at Camano Head generated a tsunami that inundated a fishing village on Hat Island (Shipmen, 2001). In addition to offshore landslides the collapses of river deltas have produced tsunamis. There are several potential sources for generating tsunamis in Puget Sound on river delta that are highly susceptible to seismic soil liquefaction and potentially prone to submarine landsliding and disintegrative flow failure (Fig. 8)

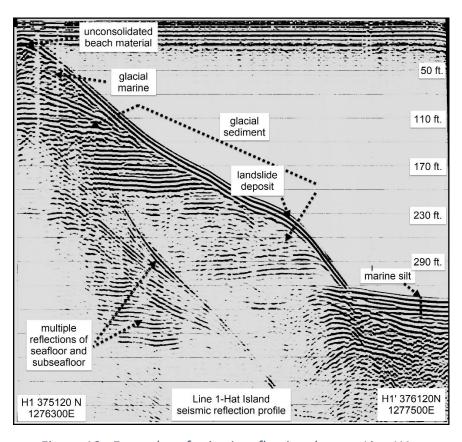
Figure 10. Examples of seismic reflection data on Line H1.

The sequence shown in the three figures is most likely characteristic of the strata that would be observed on seismic data obtained along other areas of the eastern shoreline of Hat Island.

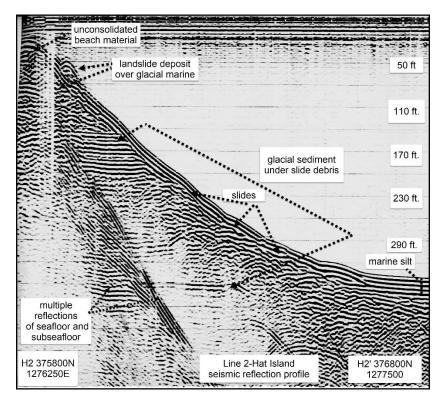
Figure 11. Examples of seismic reflection data on Line H2.

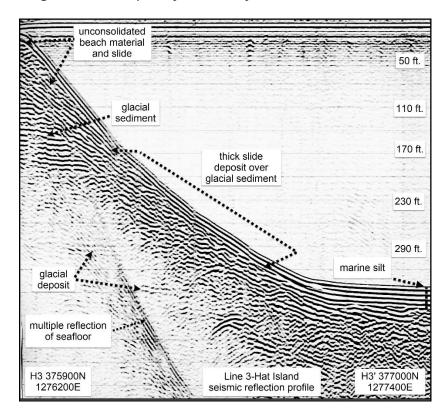
Figure 12. Examples of seismic reflection data on Line H3

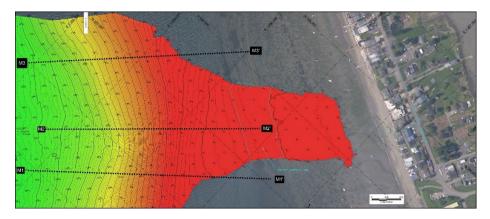
Figure 14. Location of transects for seismic reflection data shown in Figures 15, 16 and 17.

Subbottom seismic reflection data were acquired on a series of parallel transects offshore of Tulalip/Mission Beach (Fig.14).

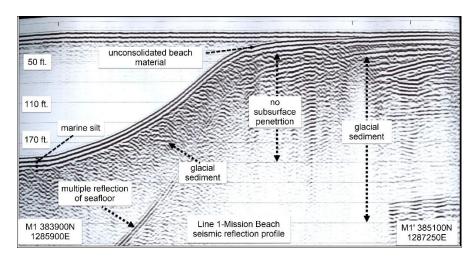
Figure 15. Example of seismic reflection data on Line M1.

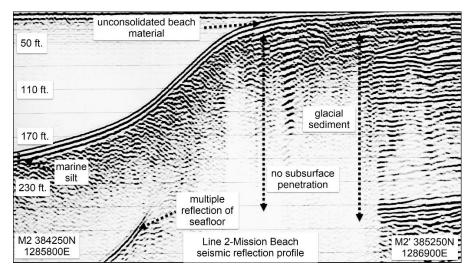
Figure 16. Example of seismic reflection data on Line M2

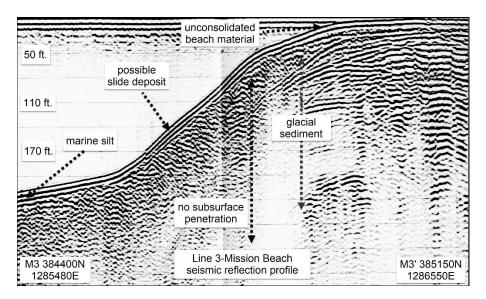
Figure 17. Example of seismic reflection data on Line M3

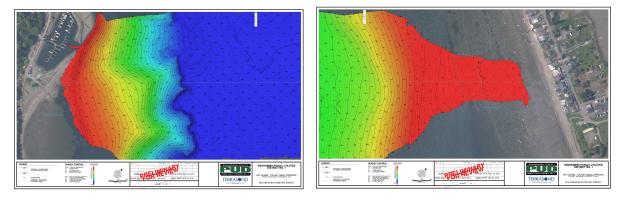
Figure 20. Bathymetry offshore Hat Island (left) and Mission Beach (Terrasond Ltd., 2019)

1. Bathymetric Survey: A multibeam bathymetric survey was conducted along a corridor centered on the existing cable route. The corridor was approximately 1200 feet wide and narrowed to 200 feet at each landing. Images of the bathymetric contours for Hat Island and Mission Beach, are presented below (Fig. 20). Not shown near Hat Island is a possible sunken barge located 450 feet north of the centerline (377,700N, 1,278,100E). It is quite apparent that the seafloor on the Hat Island landing is considerably more complex, with incised canyons and escarpments, compared to the gentle slope on Mission Beach. The entire profile shows that the seabed in deep-water (approximately 340 feet) is extremely flat. The locations of the existing power cable, mapped using a magnetometer and sidescan sonar, is near the as-built cable location (Figs. 20 and 21).

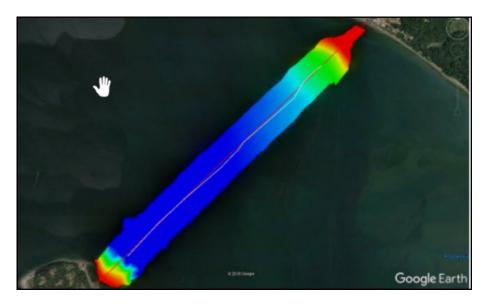
Figure 21. Bathymetry along cable route and location of existing cable (Terrasond Ltd, 2019).

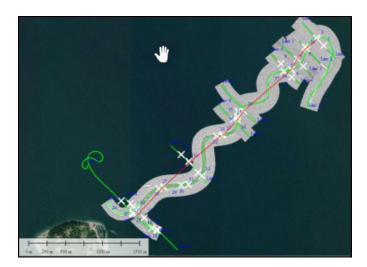
Figure 22. Magnetometer and sidescan sonar data. White marks are location of magnetic anomalies Bathymetry along entire cable route and location of existing power cable based on interpreted magnetometer and sidescan sonar data (Terrasond Ltd., 2019).

2. Cable Survey: Data were acquired with a magnetometer and sidescan sonar to locate the actual position of the existing cable within the cable corridor. The sidescan sonar only detected the cable at the base of the slope near Hat Island. This suggests that the cable is buried in the soft sediment in deep-water and beneath landslide material on each slope. However, the magnetometer was able to detect several magnetic anomalies as the survey vessel traversed back and forth across the cable corridor. These magnetic anomalies are interpreted to indicate the presence of ferrous objects including the existing power cable and possibly crab pots or miscellaneous debris (Fig. 22).

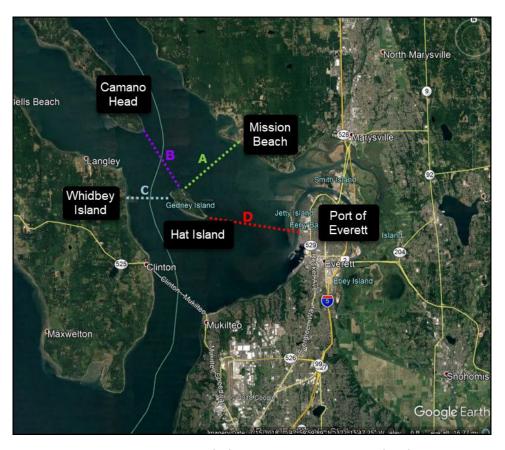
Figure 23. Proposed alternate routes to Hat Island.

Four crossing routes are being evaluated for installation of the replacement marine cable to Hat Island (Fig. 23). These crossings originate at Mission Beach (A), the existing cable route, Camano Head (B), Whidbey Island (C), and Everett (D) and terminate at the appropriate location on Hat Island.

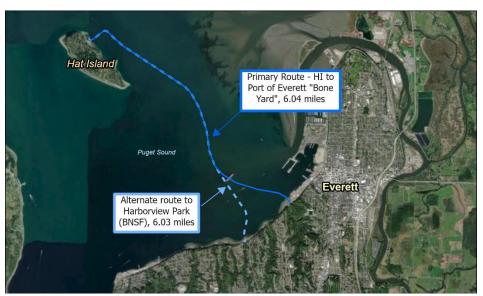
Figure 1-1. Hat Island to Port of Everett Preliminary Cable Route Including alternative landing at Harborview Park

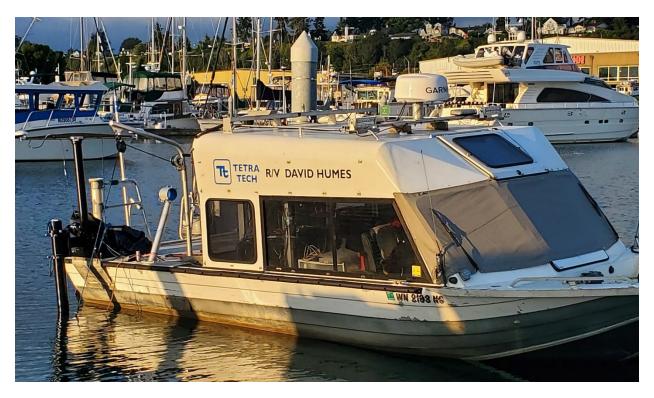
Figure 2-1. Tetra Tech Survey Vessel with R2Sonic 2026 MBE on Starboard Stern

The 24-foot survey vessel, R/V David Humes shown in Figure 2-1, was mobilized to Everett, WA and calibrations, including a multibeam patch test, were completed before commencing the bathymetric survey.

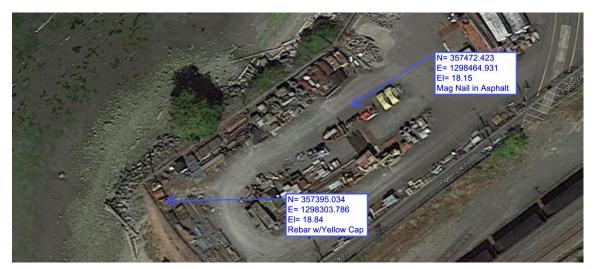
Figure 2-3. Survey Control Established at the Port of Everett by the District

Prior to mobilizing for the bathymetric survey Tetra Tech coordinated with the District's survey department manager (Michael Lynch) who established control on Port of Everett Property as shown in Figure 2-3 and Figure 2-4. The control information is provided in Table 2-3.

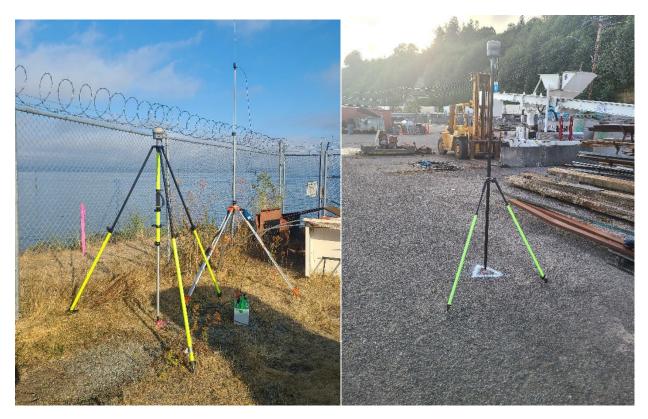
Figure 2-4. Photos of the District's Survey Control on Port of Everett Property (rebar w/ yellow cap photo on left used for RTK and mag nail in asphalt photo on right)

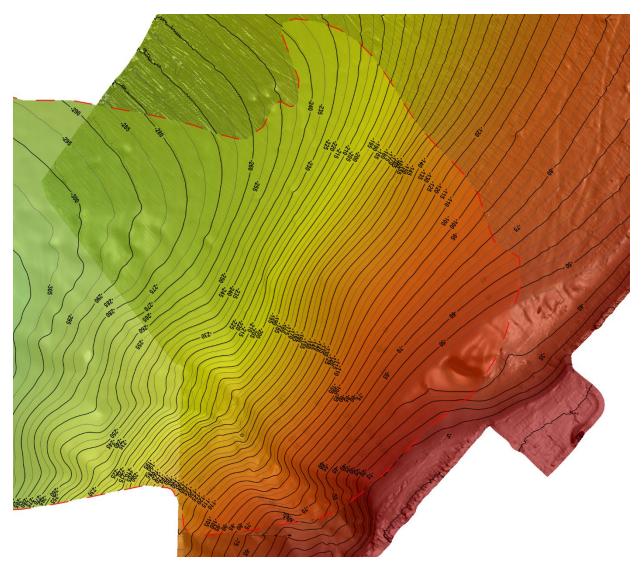
Figure 2-9. Data Comparison between Tetra Tech Data Recorded in this Survey, and an Overlapping Survey Area from 2017

As a final comparison an area of overlap between this survey and MBE data previously collected by Tetra Tech, in 2017, off the Everett landing was examined. The two surveys showed excellent alignment with contours closely matching over most of the area, and some variations attributed to sediment movement identified around Pigeon Creek outflow. An example of the comparison with the new data on top and the border identified in dashed red is provided in Figure 2-9.

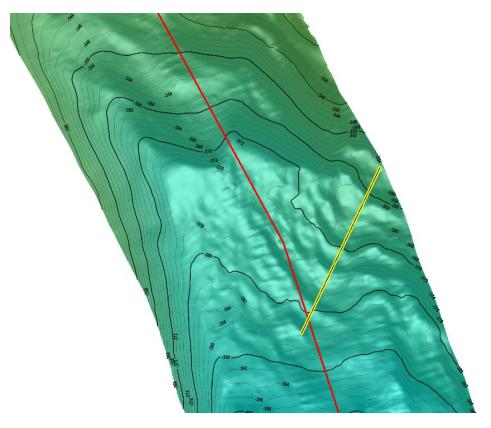
Figure 4-1. Seabed descends steeply and route crosses the tow of a turbidity flow.

In the narrowest portion of the channel, mid-way between the landings, the seabed drops steeply to the maximum depth along the roue of approximately 454 feet and the route crosses a turbidity flow where sediments have spread into a fan shape that abuts the eastern slope of Hat Island (Figure 4-1 and Figure 4-2).

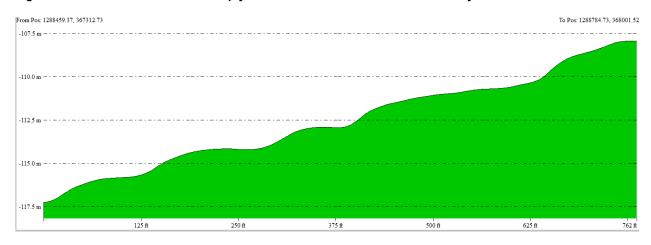
Figure 4-2. Cross-sectional profile through an area of side slopes

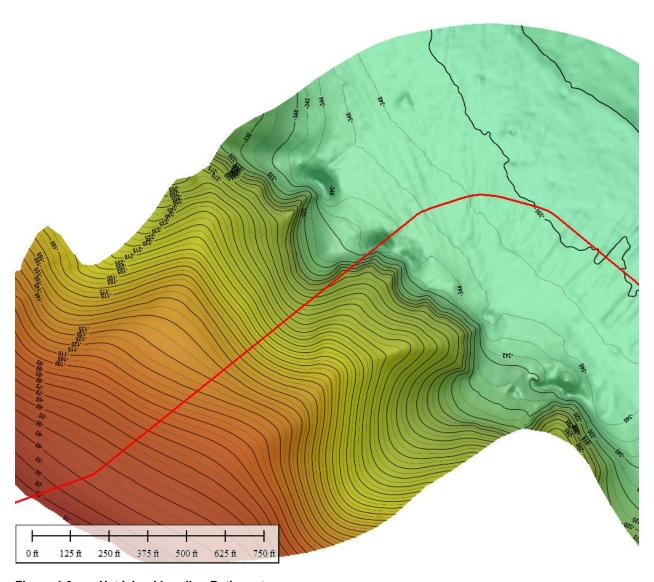
Figure 4-3. Hat Island Landing Bathymetry

The bathymetry at Hat Island has a moderate slope (5°-10°) from the shallow water limit of the survey to approximately 60 feet of water, then the seabed descends steeply to very steeply (15° to >20°) to the base of the slope at approximately 340 feet deep before essentially flattening out (slopes generally <1°) (Figure 4-3).

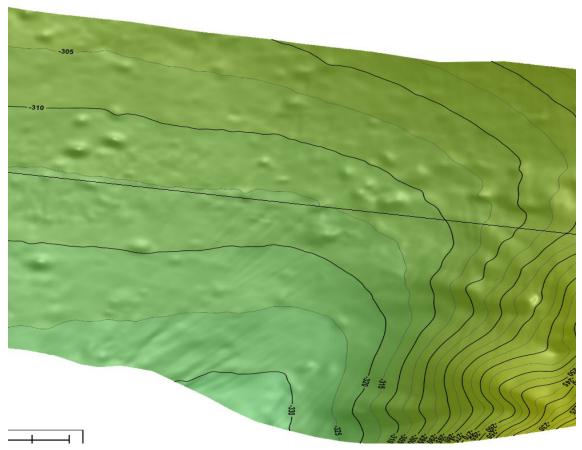
Figure 4-4. Approach to Everett Primary Landing

The bathymetry towards the approach to the Primary landing shoals gently to approximately 310 feet of water. From approximately the 330-foot contour to the base of the slope numerous point features are scattered across the corridor. These objects, typically under 2 feet in height, are likely boulders or glacial erratics or other obstructions (Figure 4-4).

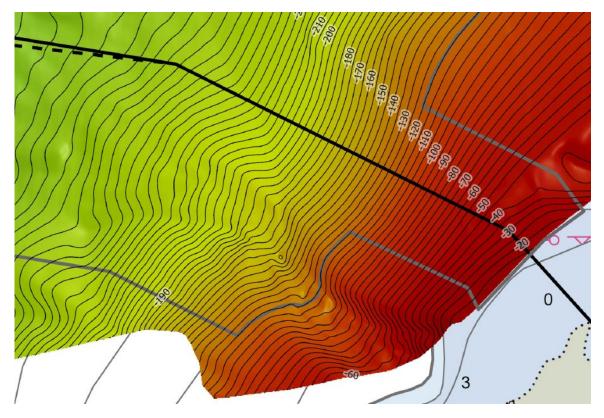
Figure 4-5. Slope to Everett Primary Landing

The approach to the Primary Landing area also includes a prominent seabed scar (potential anchor drag scar) detailed in Section 4.2.

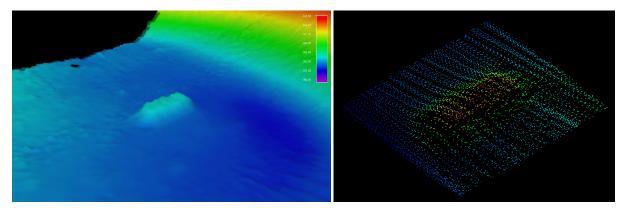
The object detected at the Alternative Everett Landing is rectangular in shape and measures approximately 110 feet x 45 feet, with a height of approximately 5 feet. The top appears generally flat (Figure 4-6).

Figure 4-6. Alternate Everett Landing Object 1

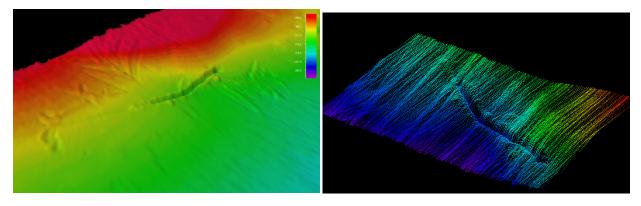
The largest and deepest scar is approximately 500 feet in length and 18 feet wide. These features are likely anchor drag scars.

Figure 4-7. Primary Everett Landing Seabed Scars

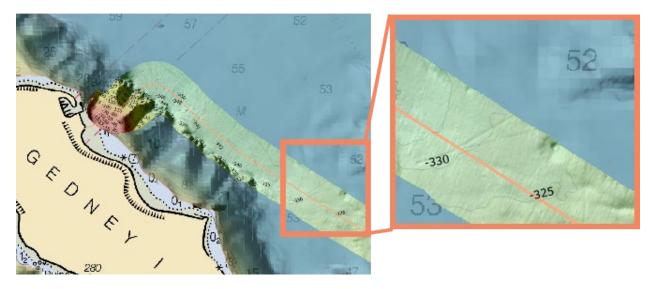
Additional seabed scars were detected approximately 1.3 miles from the Hat Island landing. Two scars form a 'Y' shaped depression oriented approximately N70°E. Another, less distinct scar oriented N3°W was detected approximately 2,000 feet to the east along the route. The first set of scars are 0.3 to 0.9 feet deep compared to the surrounding seabed, generally deepening toward its western extent, and are approximately 20-30 feet wide with no furrows Figure 4-8).

Figure 4-8. Linear Seabed Scars Near Hat Island
