SNOHOMISH COUNTY FISH AND WILDLIFE HABITAT CONSERVATION AREAS (FWHCA) ASSESSMENT

HAT ISLAND SUBMARINE POWER CABLE REPLACEMENT PROJECT

OCTOBER 23, 2024

JEN-JAY, INC.

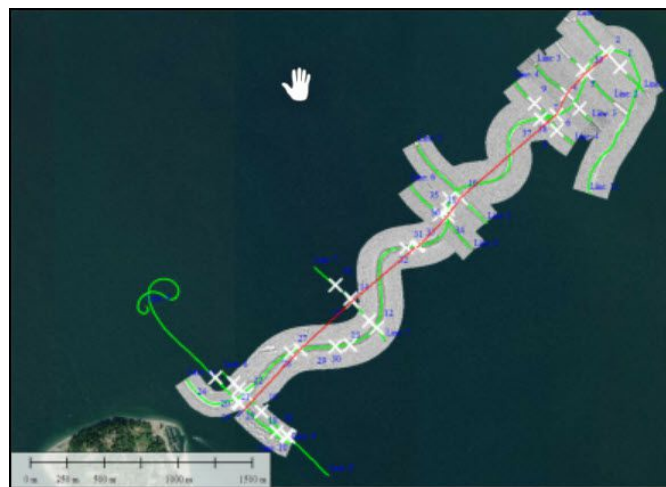
2. Cable Survey: Data were acquired with a magnetometer and sidescan sonar to locate the actual position of the existing cable within the cable corridor. The sidescan sonar only detected the cable at the base of the slope near Hat Island. This suggests that the cable is buried in the soft sediment in deep-water and beneath landslide material on each slope. However, the magnetometer was able to detect several magnetic anomalies as the survey vessel traversed back and forth across the cable corridor. These magnetic anomalies are interpreted to indicate the presence of ferrous objects including the existing power cable and possibly crab pots or miscellaneous debris (Fig. 22).

Figure 22. Magnetometer and sidescan sonar data. White marks are location of magnetic anomalies Bathymetry along entire cable route and location of existing power cable based on interpreted magnetometer and sidescan sonar data (Terrasond Ltd., 2019).

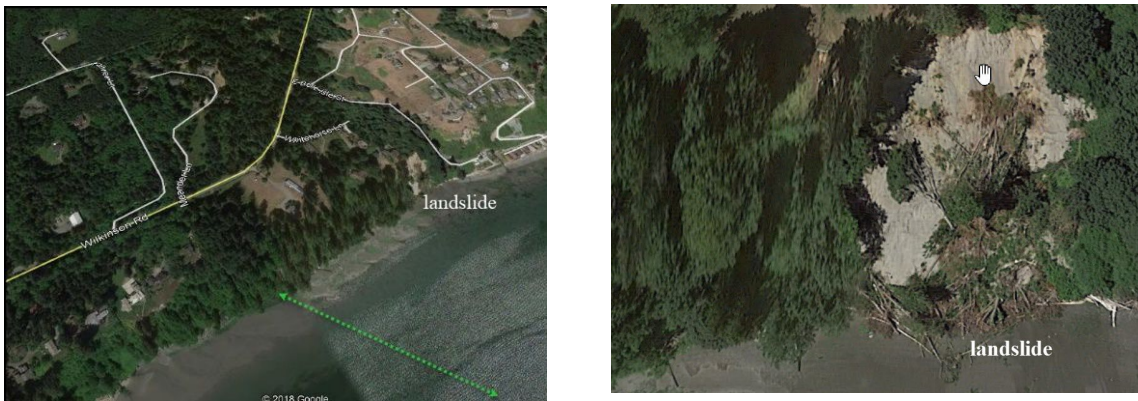
At this landing impermeable soils, silt or clay, are mixed with granular soils including sand and gravel. This combination is highly prone to failure particularly on the heavily forested, steep slopes. Large trees leaning downslope are evidence of active slope movement and may result in a catastrophic slope failure such as is evident in the right hand image below (Fig. 26).

Figure 26. East shoreline of Whidbey Island showing Alt Route C and landslide

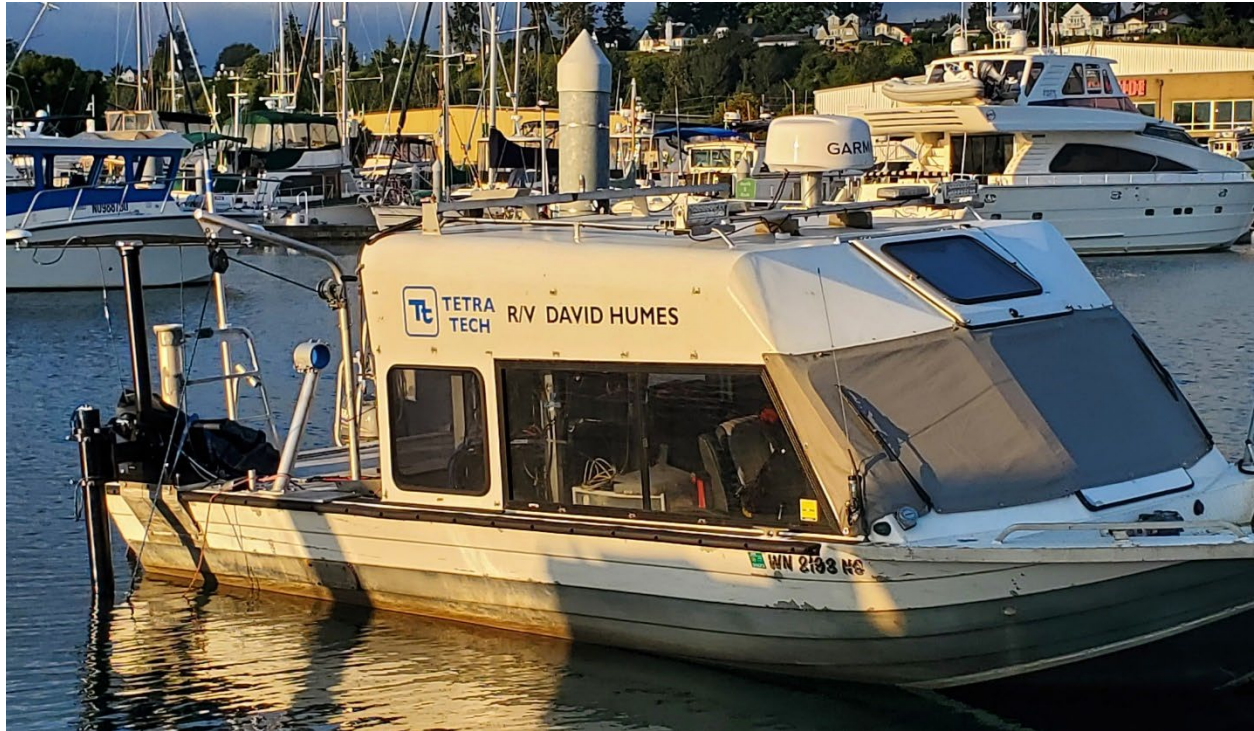
Figure 2-1. Tetra Tech Survey Vessel with R2Sonic 2026 MBE on Starboard Stern

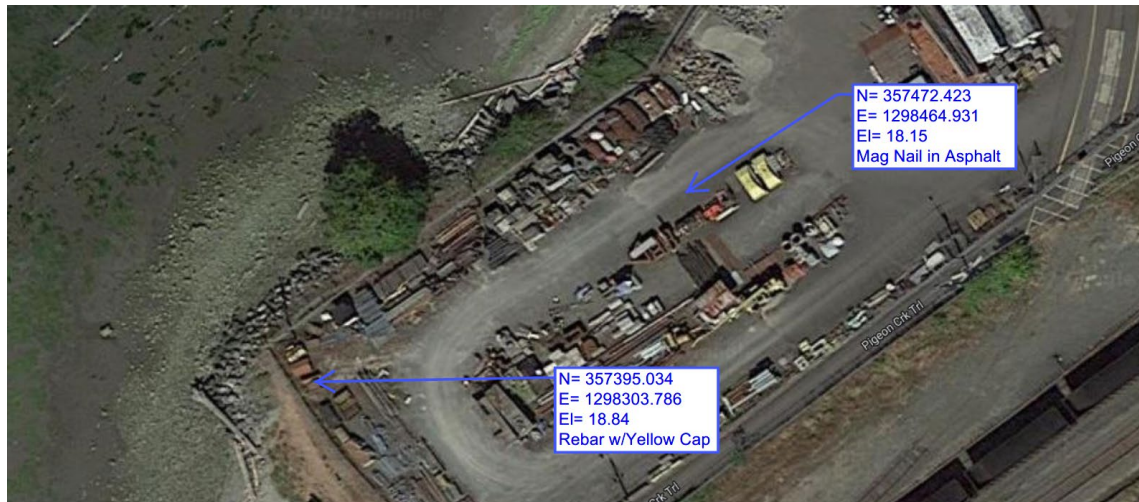
Figure 2-3. Survey Control Established at the Port of Everett by the District

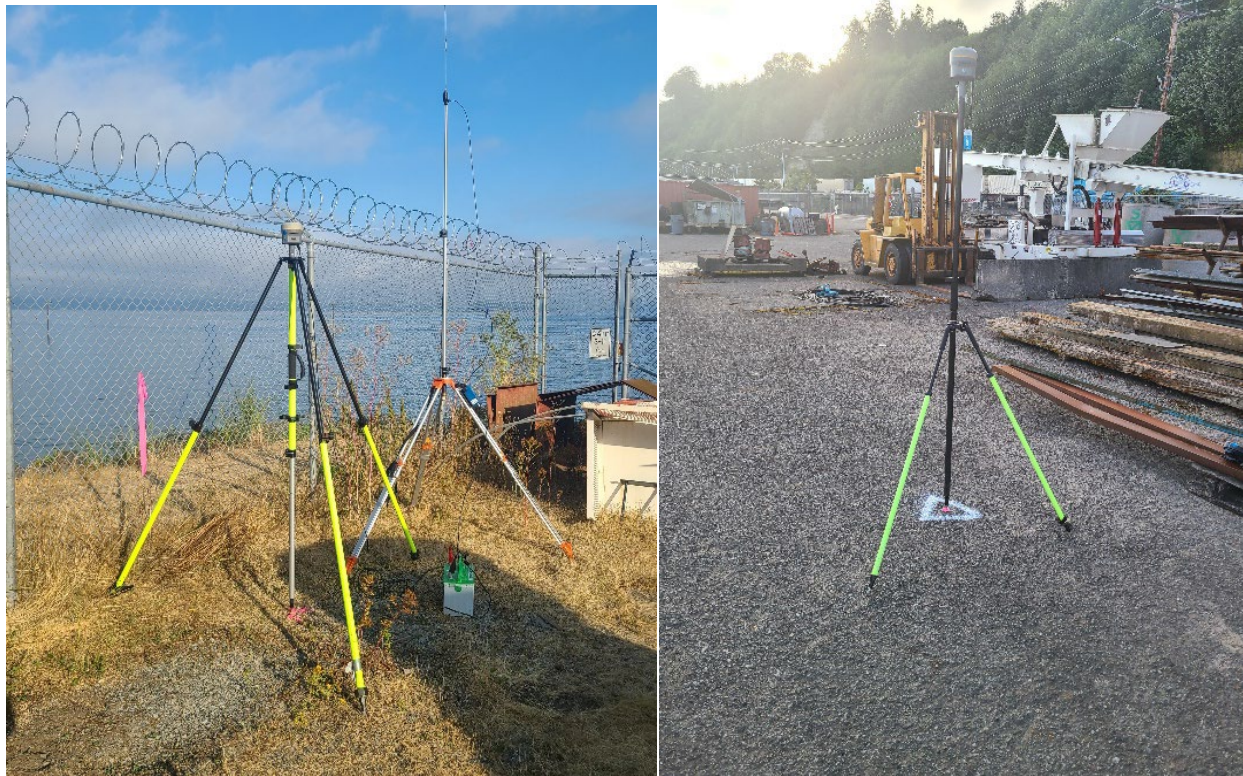
Figure 2-4. Photos of the District’s Survey Control on Port of Everett Property (rebar w/ yellow cap photo on left used for RTK and mag nail in asphalt photo on right)

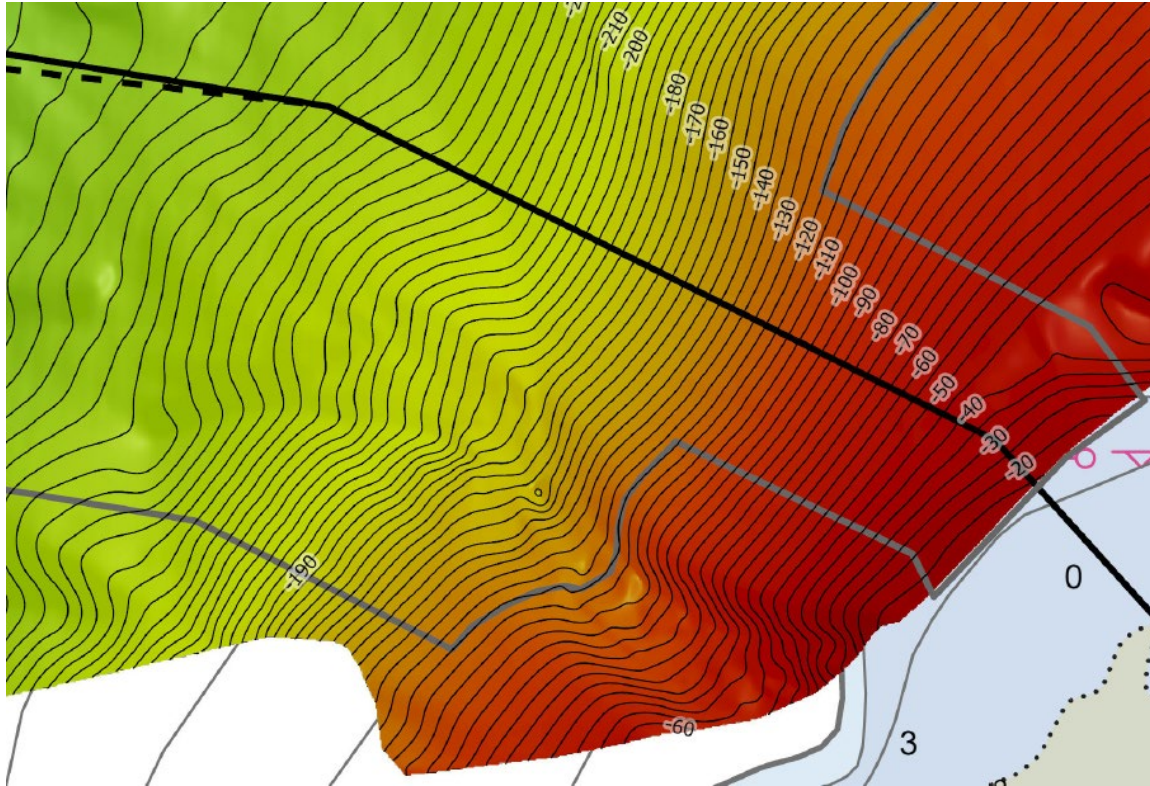
Figure 4-5. Slope to Everett Primary Landing
