Henry M. Jackson Hydroelectric Project  
FERC No. 2157

**TERRESTRIAL RESOURCES  
2023 ANNUAL REPORT**

**April 2024**

Public Utility District No.1 of Snohomish County

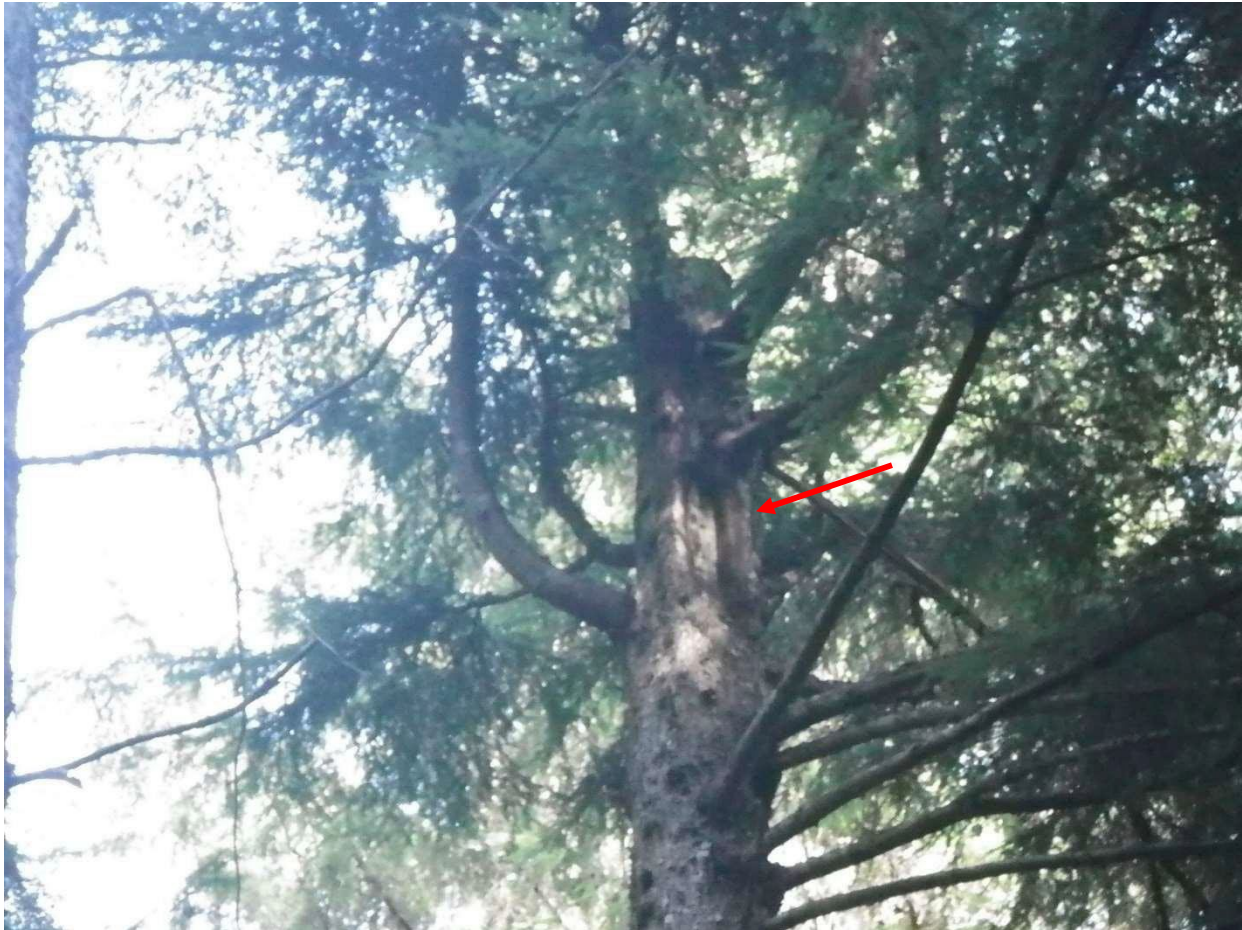
**Figure 2-3** Created decaying live tree with “cat-faced scar” created near top (red arrow) and up- turned branches forming dense, bushy top.

Preliminary results of the gap and WHS monitoring are encouraging. Many of the DLTs still survive and have upper branches turning upwards to form dense new tops (Figure 2-3). The age range of gaps sampled was from 3-11 years (from time of initial WHS creation). Within gaps, the average percent vegetative cover increased from primarily devoid of vegetation to a range of 40-68% (Figures 2-4 & 2-5). In terms of deer forage, nearly every gap had vaccinium and salmonberry, with typical heights ranging from 2-8 feet, with numerous gaps having evidence of deer browsing.

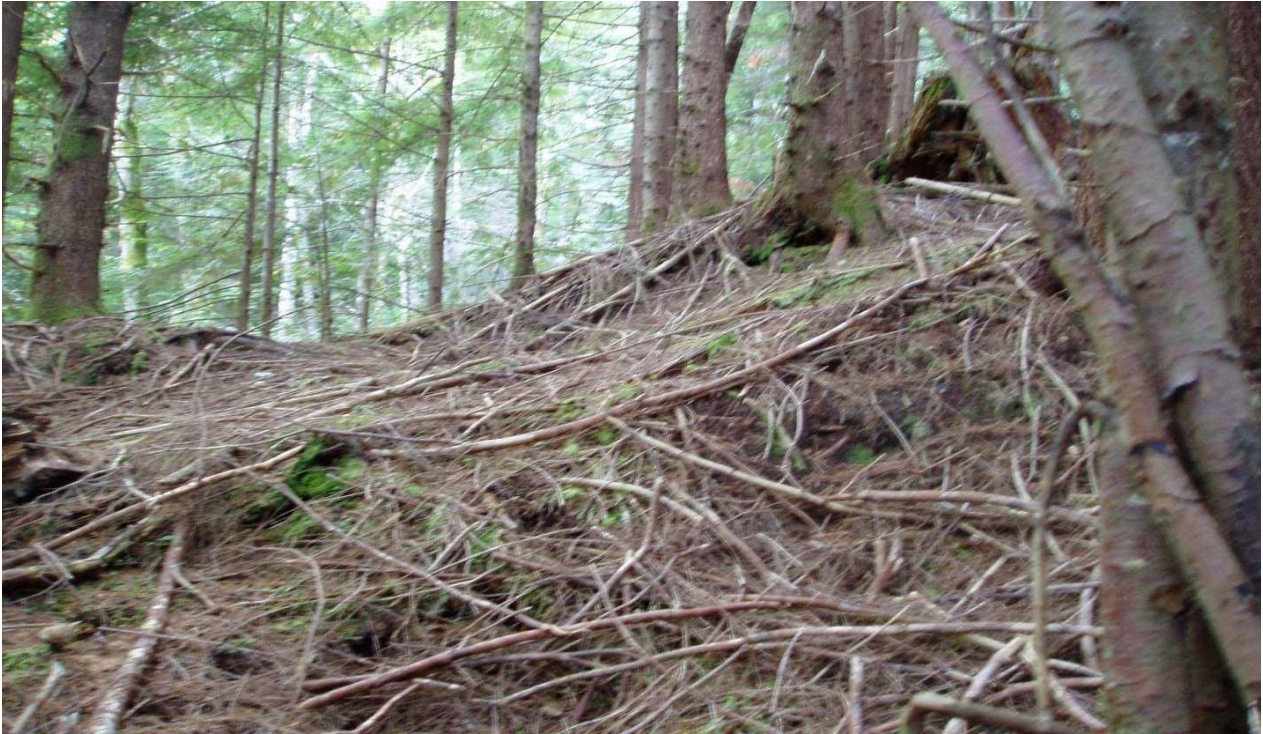
**Figure 2-4** Typical understory in stands where no commercial thinning or gap creation has occurred.

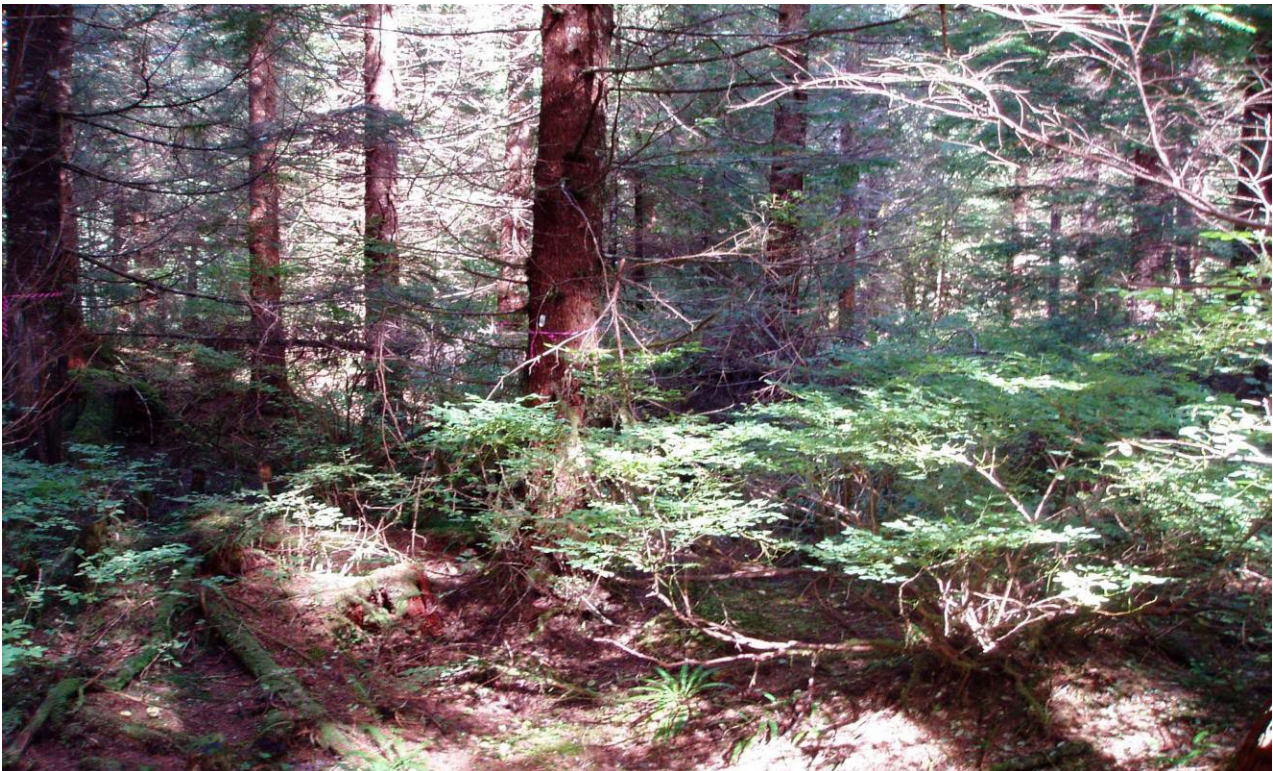
**Figure 2-5** Post-gap creation, showing strong evidence of the impact of increased light input to gap.

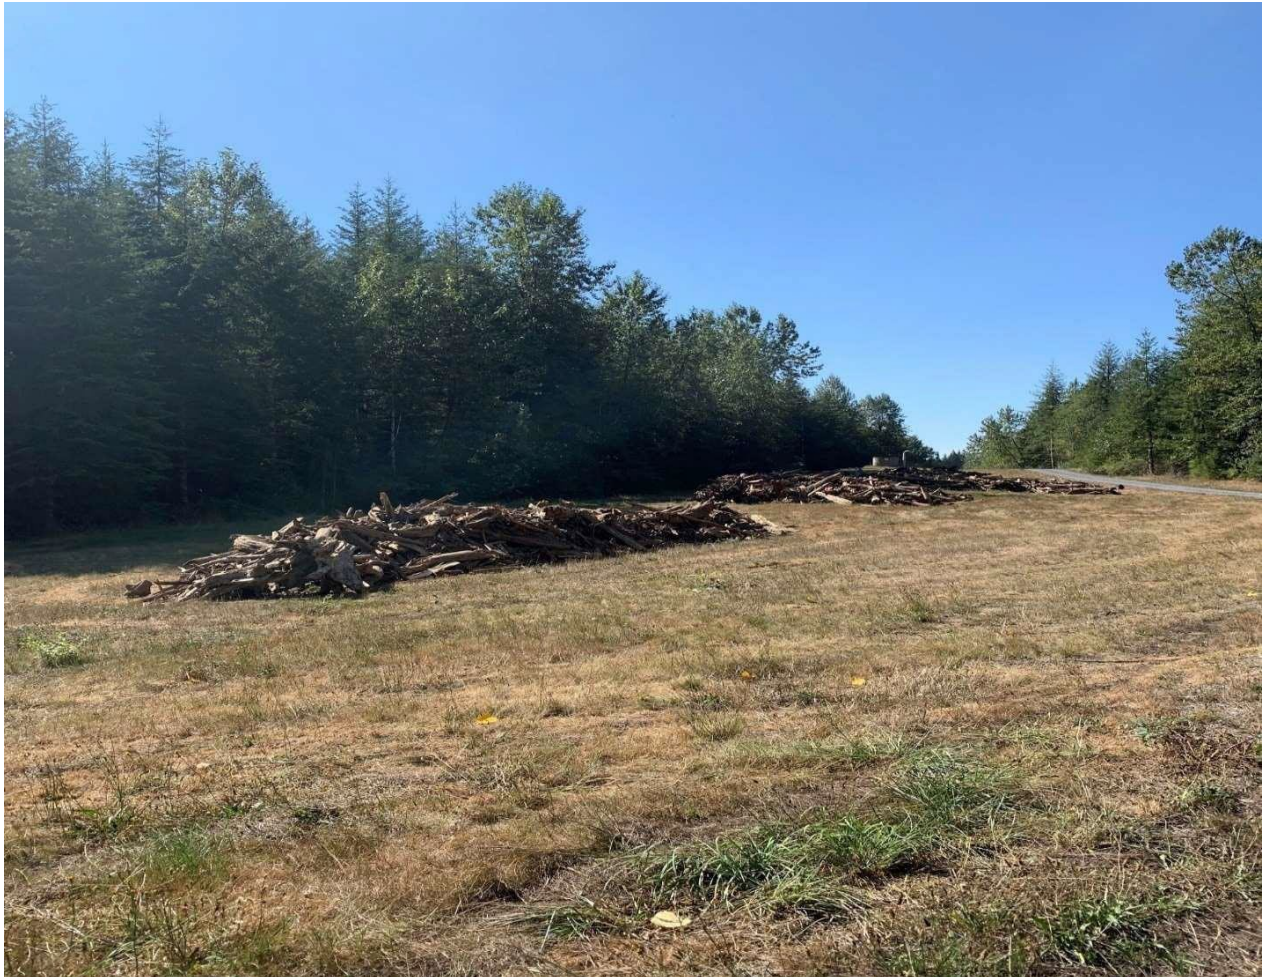
**Figure 2-6** Woody debris piles deposited near P4 on lower pipeline ROW.

Several truckloads of wood from Culmback Dam that were not suitable for deposit into the riverine system were deposited on the lower pipeline ROW to provide hiding cover for small mammals and to break up the line of sight (Figure 2-6).
